Building Inspection Report

8251 PETERS Ave. M.C. CA 92655

Inspection Date:
09/21/2010

Report Number:
2010-151

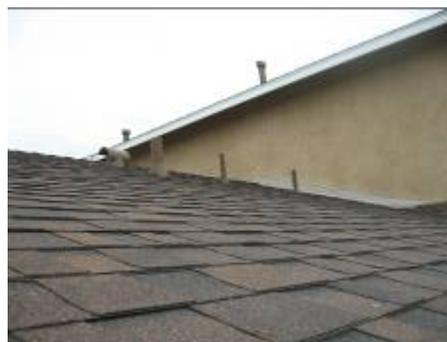
Figure 1: Roof coverage

The roof coverings are newer and appear to be in generally good condition. Roof flashing details appear to be in good order. The chimneys do not show signs of significant deterioration. In all, the roof coverings show evidence of normal wear and tear for a home of this age.

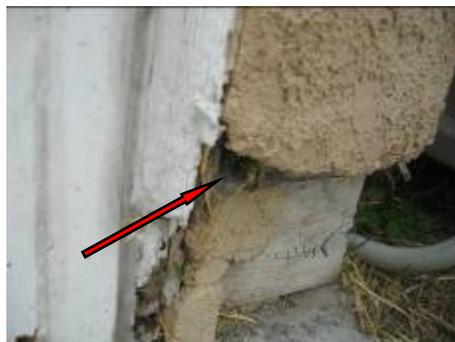
- **Repair:** Localized damage of the stucco exterior walls (staining and or cracks) should be repaired. There is extra risk of hidden damage in such areas caused by previous or present leaks that should be sealed. (front garage)
- **Repair :** windows' screens

Figure 2: Exterior wall damaged at garage

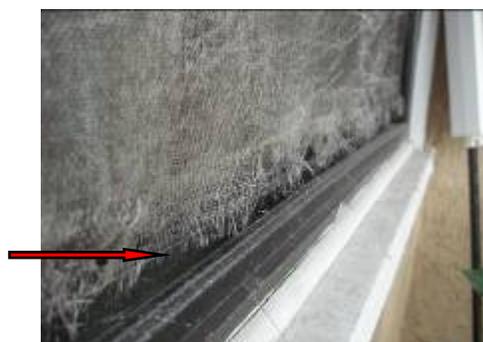
Figure 2: Screen damaged

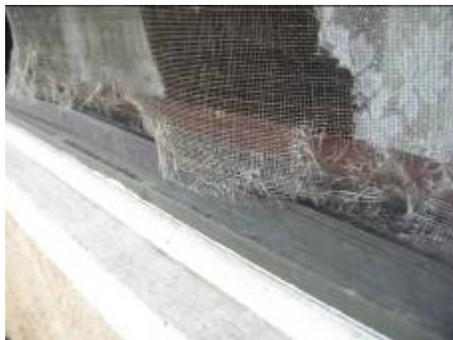
Figure 3: Screen damaged

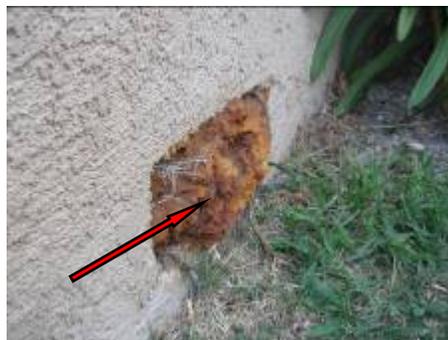
Figure 4: Garage ventilation has been blocked

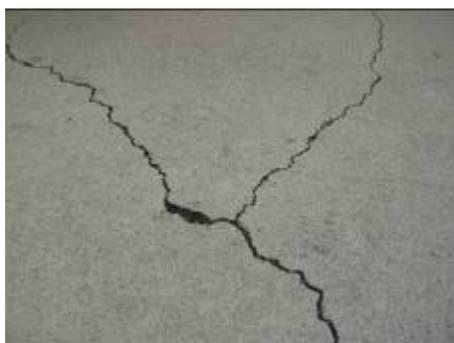
Figure 5: Normal concrete cracks less than 1/4"

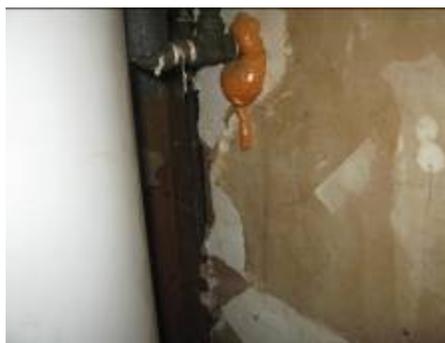
Figure 6: Wall damaged in garage

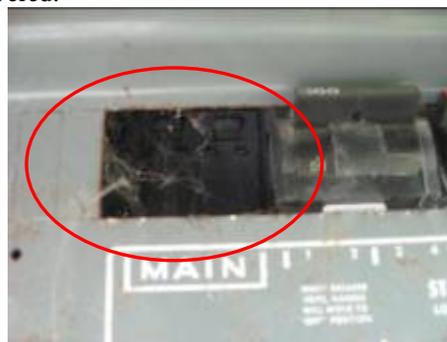
Figure 7

- **Safety Issue:** Any openings in the main panel should be covered.

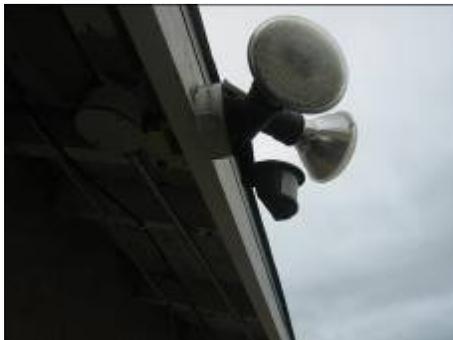
Figure 8: sensor is not tested

- **Repair:** The installation of smoke detectors outside sleeping areas is recommended.

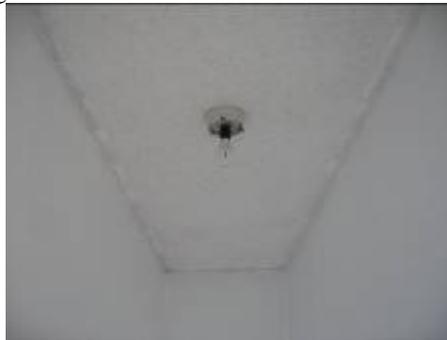
Figure 9: Stairs light is not on

- **Repair:** The light is inoperative. If the bulbs are not blown, the circuit should be repaired.

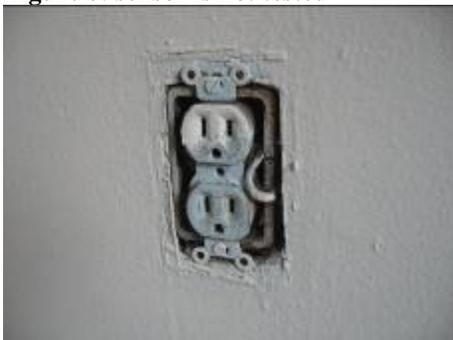
Figure 10: No cover

- **Repair:** Missing outlet cover plates should be replaced to avoid a shock hazard.
- **Safety Issue:** Any openings in the main panel should be covered.

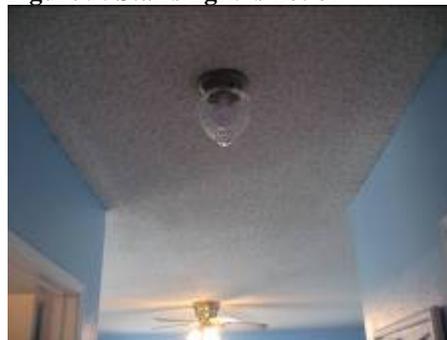
Figure 11: Light is not on

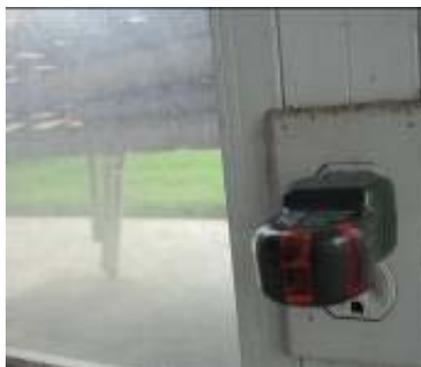
Figure 12: No power at patio outlets

- **Repair :** There is no power at outlets in patio enclosure.

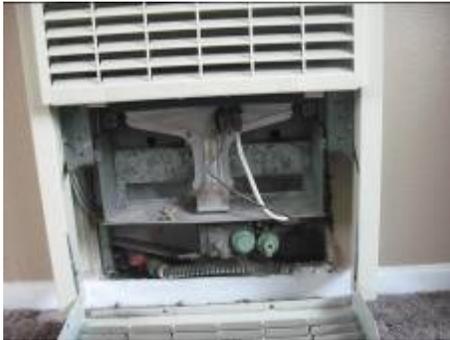
Figure 13: Not operating when testing

- **Repair:** The heating system requires service. This should be a regular maintenance item to assure safe, reliable heat.

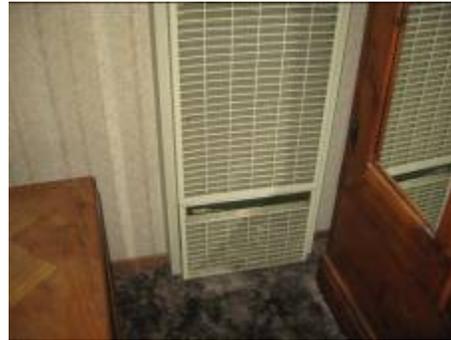
Figure 14: Wall unit is not on

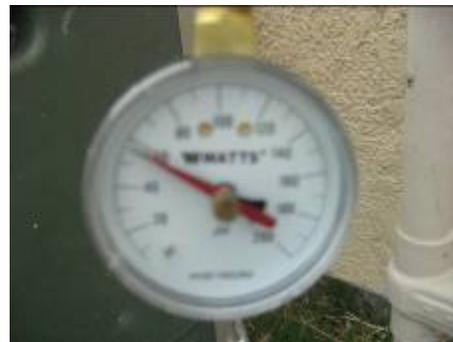
Figure 15 :water pressure 60 psi

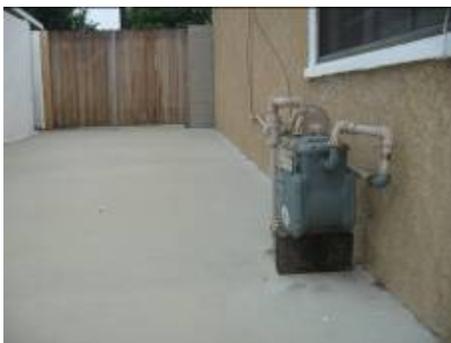
Figure 16: Gas meter should be protected.

- **Repair:** The gas meter should be better protected against mechanical damage.
- **Repair, Safety Issue:** *A gas leak was detected. This is a serious safety concern. It is recommended that the gas utility be engaged immediately. The current occupants of the home should be notified.*
- **Repair:** The flexible gas piping is not suitable to above grade installation. Please consult with a professional plumber for further evaluation

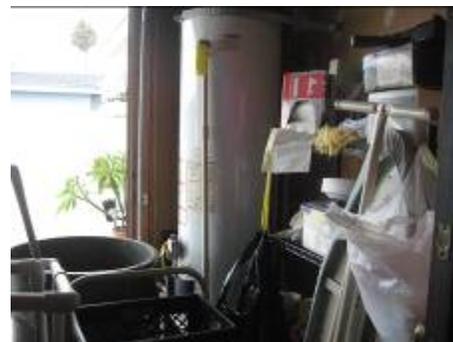
Figure 17: Straps needed for W.H.

- **Deferred Cost Item:** The water heater is an old unit that may be approaching the end of its useful life. It would be wise to budget for a new unit. One cannot predict with certainty when replacement will become necessary.
- **Repair:** Water heaters in seismic zones should be anchored or strapped to resist movement during earthquake conditions.

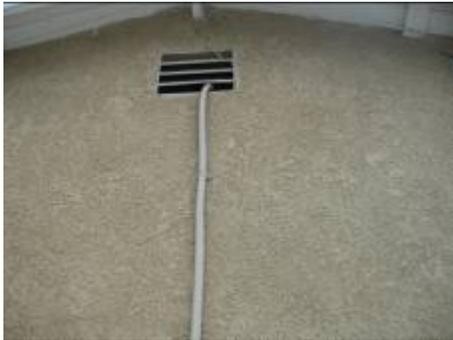
Figure 19: Flex pipe to attic ?

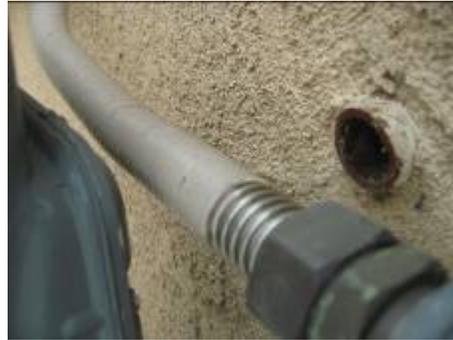
Figure 20: Flexible gas pipe ?

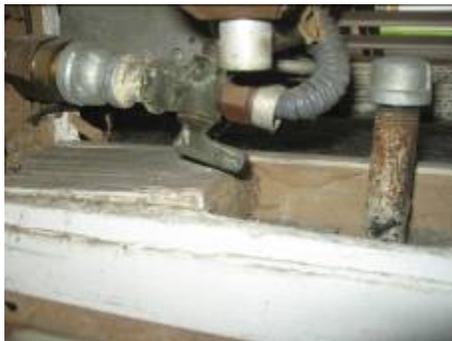
Figure 18: Possibly gas leaks at heater

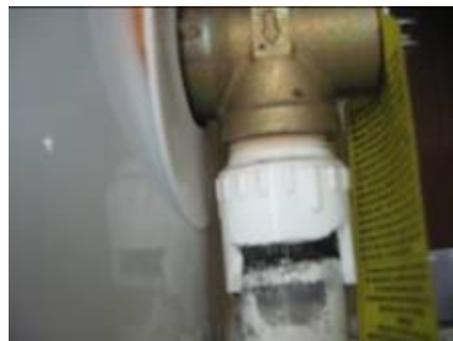
Figure 21: Water Heater: TP valve extension has been broken

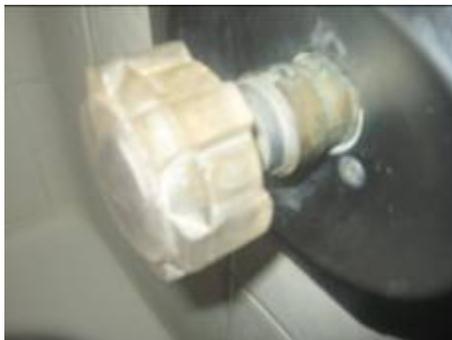
Figure 23: Aging faucet handle

- **Monitor:** The majority of plumbing fixtures are old.
- **Monitor:** The faucets are showing signs of age. Updating faucets over time should be anticipated.

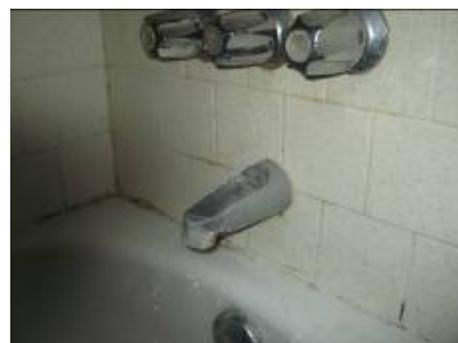
Figure 22: Aging leaking faucet

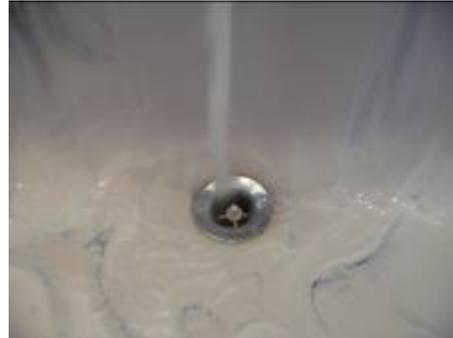
Figure 24: Missing stoppers

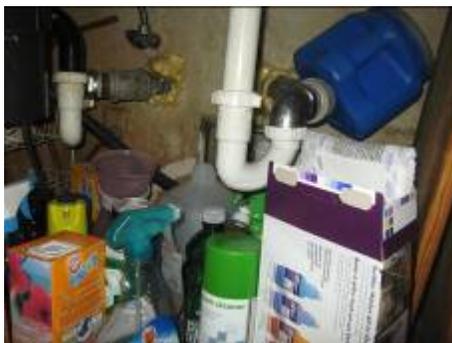
Figure 26: Limited visible inspection

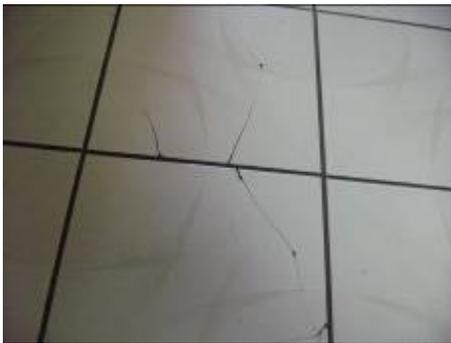
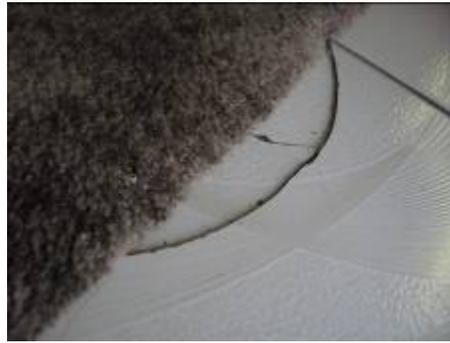
- **Monitor:** The tile floor is cracked.

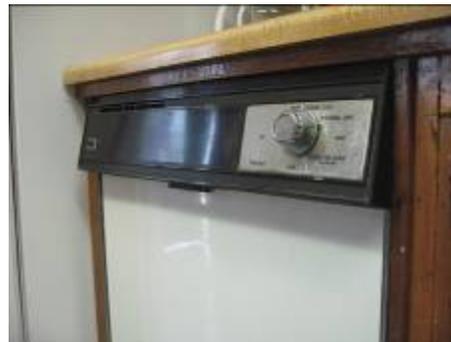
Figure 29

- **Repair:** The dishwasher is inoperative.

- **Repair:** The door seal of the dishwasher should be improved.

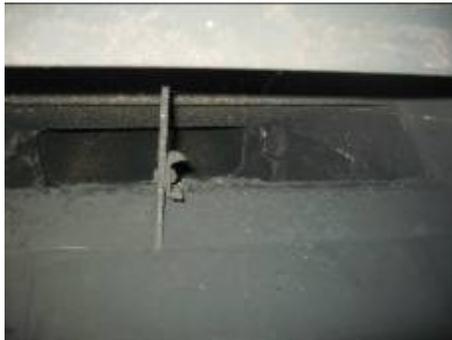
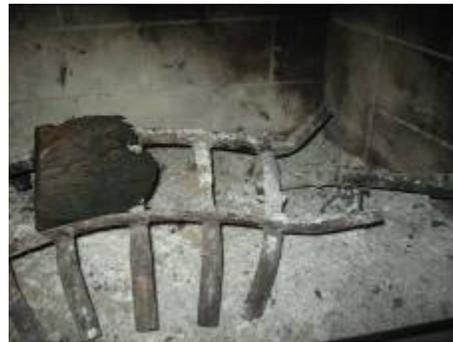
On the whole, the fireplace and its components were found to be in below average condition. When redecorating, repairs will be necessary in some areas.

- **Repair:** The fireplace chimney should be inspected and cleaned prior to operation.
- **Repair:** The fireplace damper requires repair.
